# **Test report on the pulsed water treatment system provided with preventive measures against clogging in the drainpipe under the sink in the cookery on the fifth floor.**

December 22, 2007

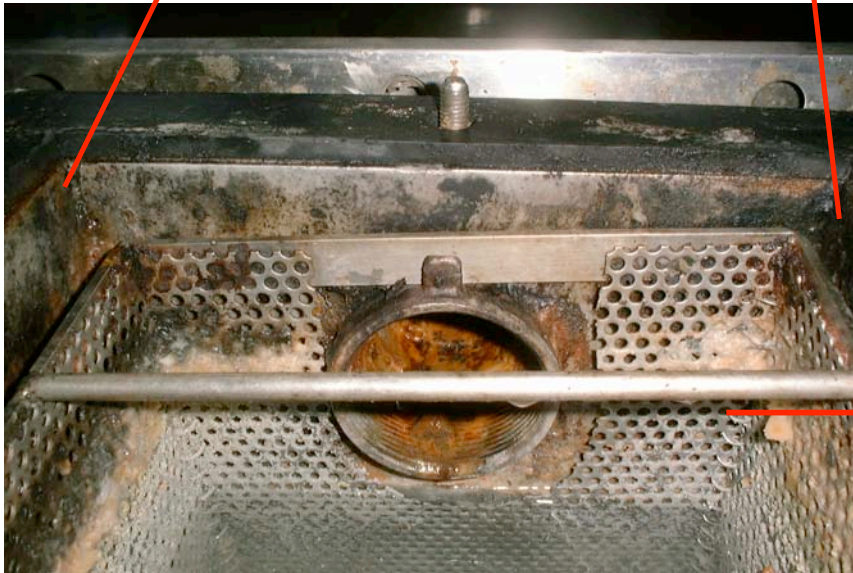
Grease trap under  
the countertop

Usual level of the standing water: Water flows up to the level indicated by ①.

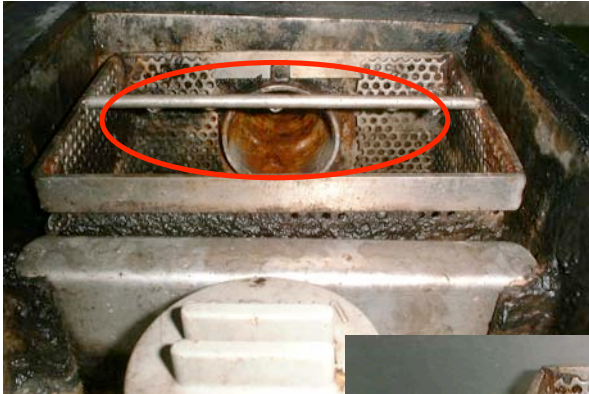
On September 12 (three months after the installation of the Vulcan)

The status of the grease trap three months after the installation:  
Compared with the time of installation, the peripheries of the basket drain have gotten dry.

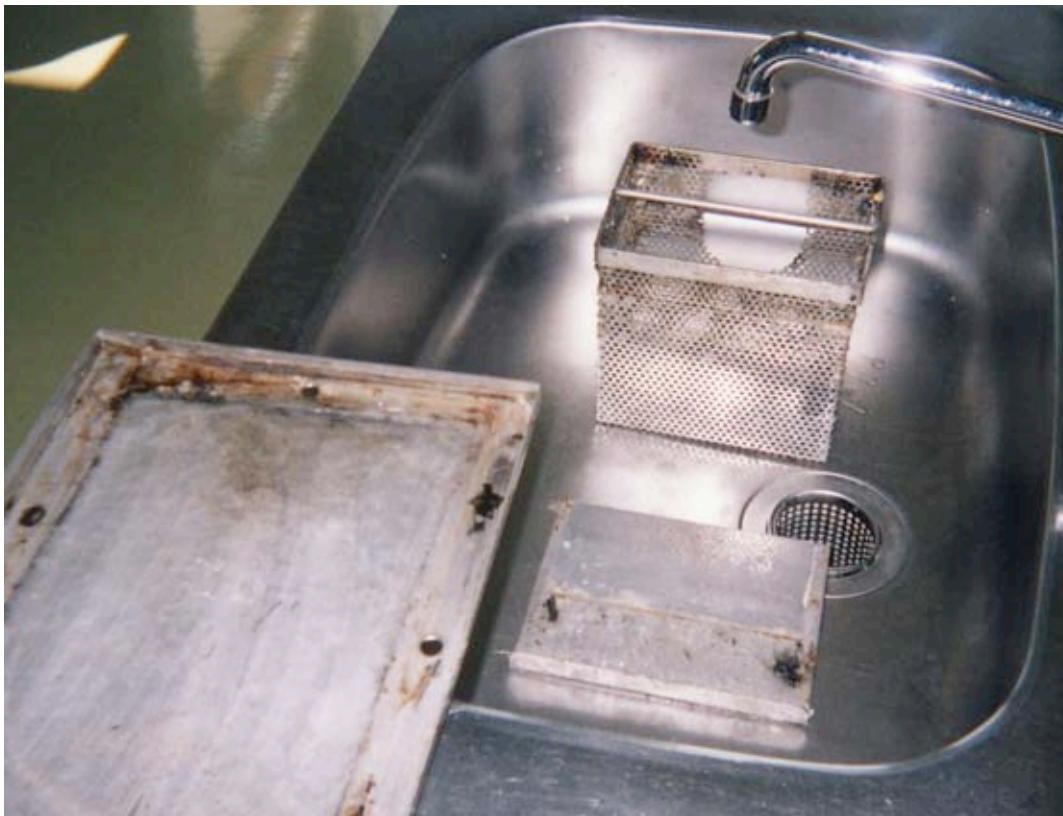
The basket taken out when cleaning the grease trap under the sink on September 20

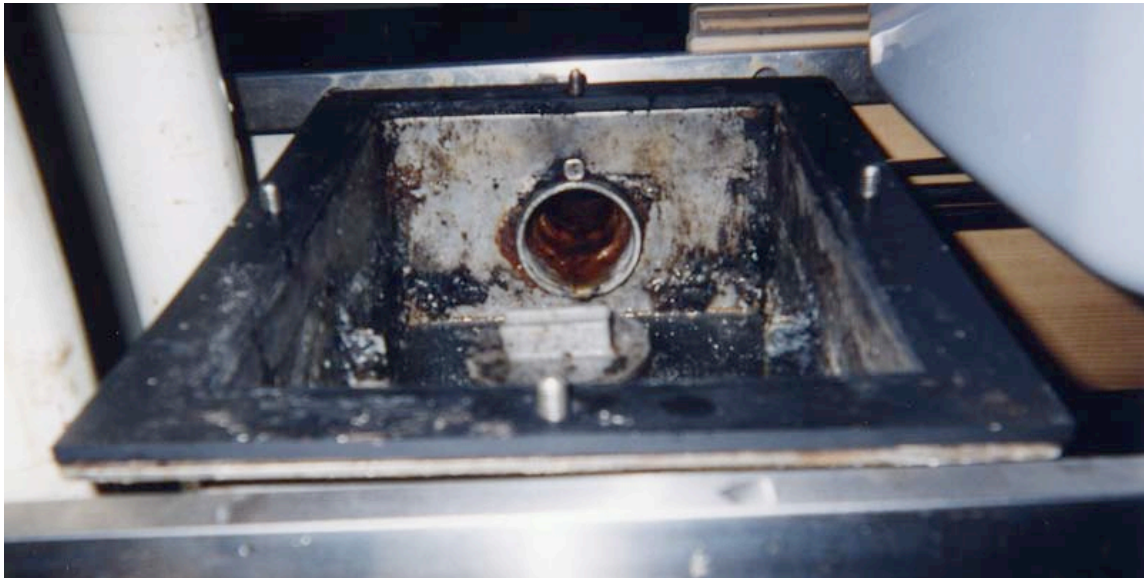
When the grease trap under the sink was cleaned on September 20, 2006
