Installation of Vulcan water treatment

Installation site: White Castle #49, Indianapolis, USA
Model: Vulcan 1000 (installed on the in the line after the carbon filters)
Vulcan 5000 (installed on the main inlet line, before the 5 micron carbon filters)

White Castle #49 – April 14, 2011

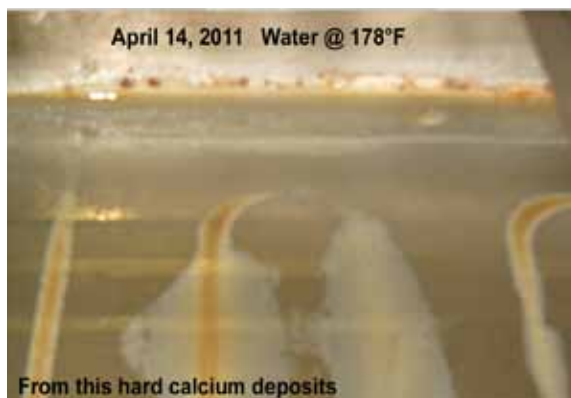
Before using Vulcan - April 14, 2011

Hard calcium deposits in the pan.

Without Vulcan
