# Test report on Vulcans (pulsed water treatment systems) installed as a preventive measure against scale buildups causing faulty of the cooling towers

February 24, 2007

**Tested field:** Factory of a pharmaceutical company

**Installation sites:** Cooling towers on the rooftop of the second building

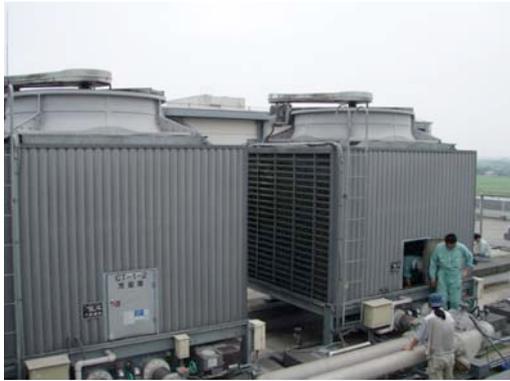
2.1 Cooling tower A  
2.2 Cooling tower B

2-1 cooling tower **A**: Makeup water piping size is 50A.

2-2 cooling tower **B**: Makeup water piping size is 50A.

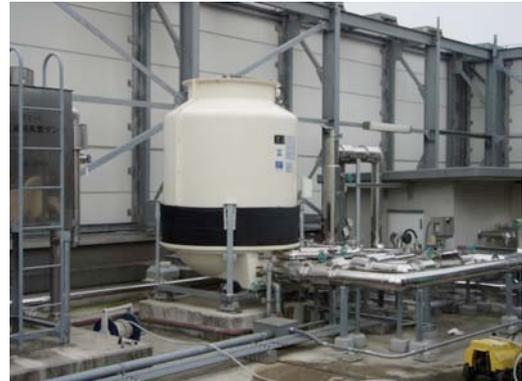
1 Cooling tower C

1 cooling tower **C**: Makeup water piping size is 50A and circulating piping size is 80A.
